Engineering Principles^a, LLC 20 Main Street, Suite 206 Natick, Massachusetts 01760

July 11, 2018

Faust v. Autoliv

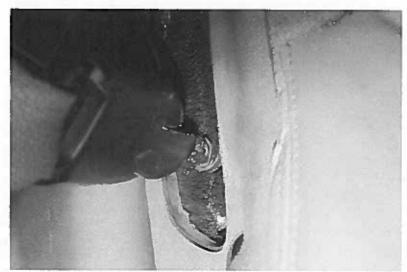
For the right-front passenger position, the webbing has been cut in two locations. The cut ends match up indicating that all of the webbing is present and accounted for. The seat-mounted outboard anchor (OBA) has a pretensioner which appears deployed (it appears retracted) (Figure 1). The latch plate was found latched in the buckle; the latch plate was removed, inspected and then latched in the buckle for safe-keeping. The cover on the latch plate is missing (Figure 2a). The latch plate is a locking latch plate design. There are load marks on the plastic clamping surface of the latch plate where it interacted with the webbing (Figures 2b-d).

Figure 1: Right-front deployed (retracted) OBA pretensioner

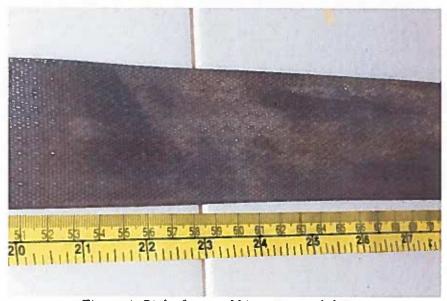
There are load marks on the D-ring (Figure 3). There is what appears to be biological material deposited on the webbing (Figure 4). There is longitudinal folding of the webbing. In its current state, the retractor will not retract webbing or allow webbing to be extracted. There is plastic transferred to the webbing from the D-ring consistent with retractor pretensioner and load limiter deployment (Figure 5). The right-front passenger's frontal airbag has not deployed.

Figure 4: Right-front webbing: material deposit

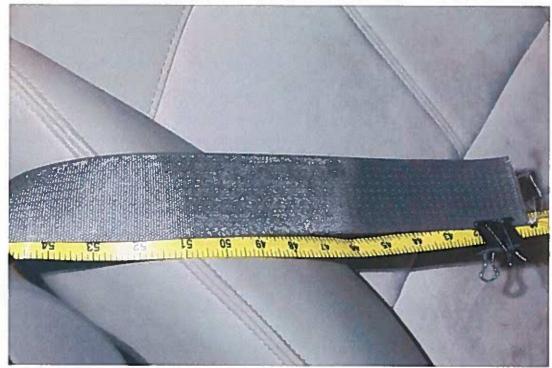
Figure 5: Right-front webbing with plastic transfer from D-ring

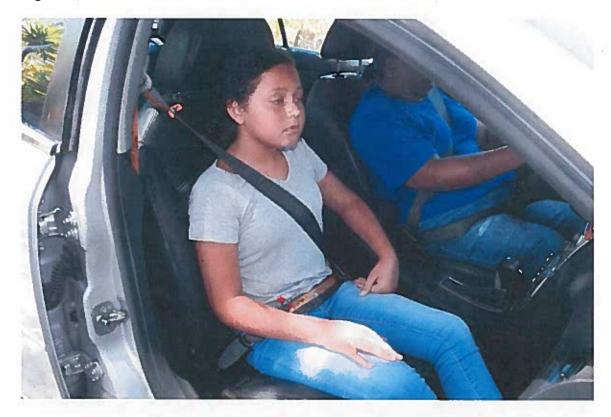
When wearing the seat belt properly, the seat belt offered good fit for an occupant the size of Keeper Figure 6). With the surrogate seated in the right-front seat, the D-ring was approximately 44 inches from the outboard anchor.

Figure 6: Surrogate properly wearing right-front seat belt

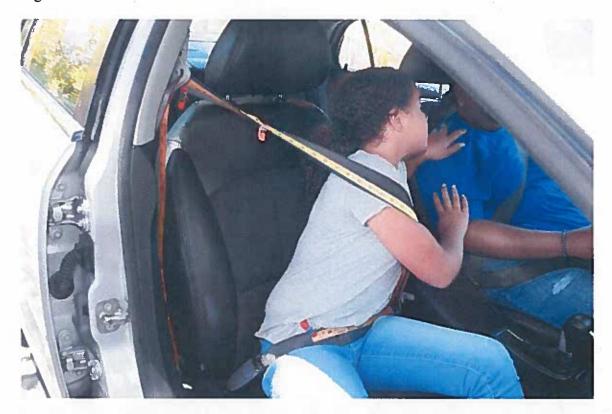
The surrogate was also placed in a pre-crash position that was consistent with the physical evidence on the subject seat belt and consistent with K provide injuries (see Figure 7). This position is consistent with K provide turning and reaching toward the driver position as one might do to alert the driver. When the surrogate did this, the belt moved off her shoulder and onto her upper arm, and the D-ring was approximately 49 inches from the outboard anchor. Based on the physical evidence on the seat belt as well as the expected function of the pretensioners, this location is consistent with the approximate location of the D-ring along the webbing at the time that the pretensioners deployed early in the crash pulse. Based on the physical evidence K providence had additional webbing in the seat belt system (as compared to a properly belted occupant), and Figure 7 illustrates one position consistent with this evidence.

Figure 7: Surrogate with D-ring at approximately 49 inches

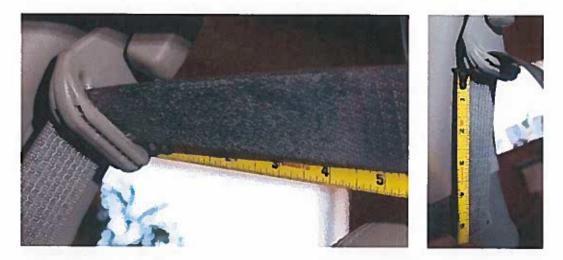
It can be seen that a portion of the webbing that was pulled forcefully over the D-ring had partially retracted back over the D-ring (Figure 9a, 9b). This is likely due in part to relaxation of the elastic stretch of the webbing. Even if the retractor had been equipped with a load limiter that had a 6-inch "stop," or a higher-threshold torsion bar, the webbing would still be designed to stretch in order to help manage occupant ride-down energy.

Figure 9a, b; Webbing with load limiter marks on both sides of D-ring
